# WORKER FALL FROM HEIGHT

## DESCRIPTION:

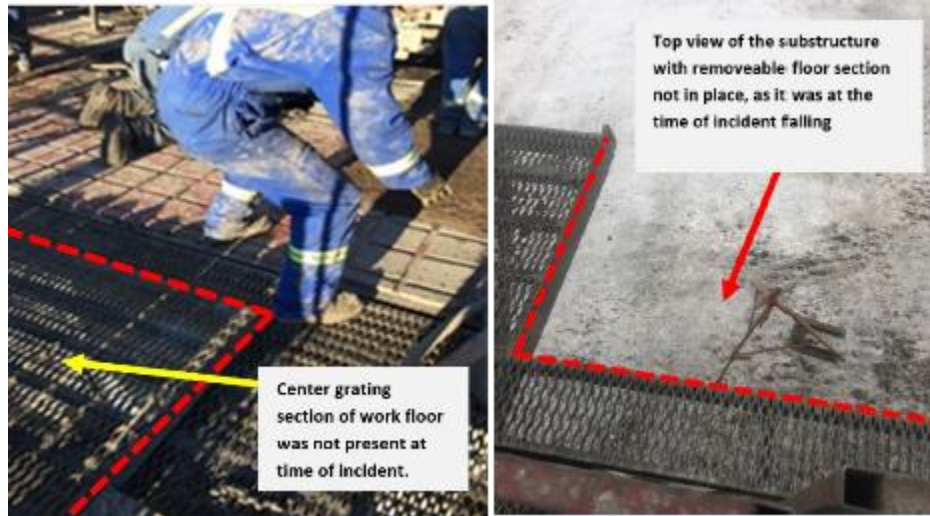
Worker fell while rigging out, as they were preparing to move to a new location. Lease hand was working on the substructure, folding down wings, when he slipped and fell over the edge approximately 3.5 meters to ground. The worker had crouched down to lift a handrail into place, his hand slipped and he lost his footing. Worker was attended by onsite medical, and then sent to nearest hospital. Worker sustained a fractured wrist.

When lowering (or raising) wings for rig-out, fall protection was not worn. No engineered fall protection system on substructure.

- JSA and site assessments did not outline all task steps or the need for fall protection
- Fall protection plan did not identify anchor points, or the requirement for fall protection for specific equipment or fall protection training
- Pre-job did not specify consistent working at height requirements

- Owner will be reviewing all working at height requirements
- Review of work plan, JSA for rigging in and out, revising pre-job hazard assessment and communicate to site workers
- Company will improve enforcement of Life Saving Rules and fall protection policy.
